U.S. Department
of Transportation

National Highway
Traffic Safety
Administration

Case Vehicle (A): 2000 Dodge
Type: Ram 1500, 4x4 pickup
Driver: 26-year-old female
CDC: 12-FCEN-1, 12-FLEE-5, 03-RFEN-1

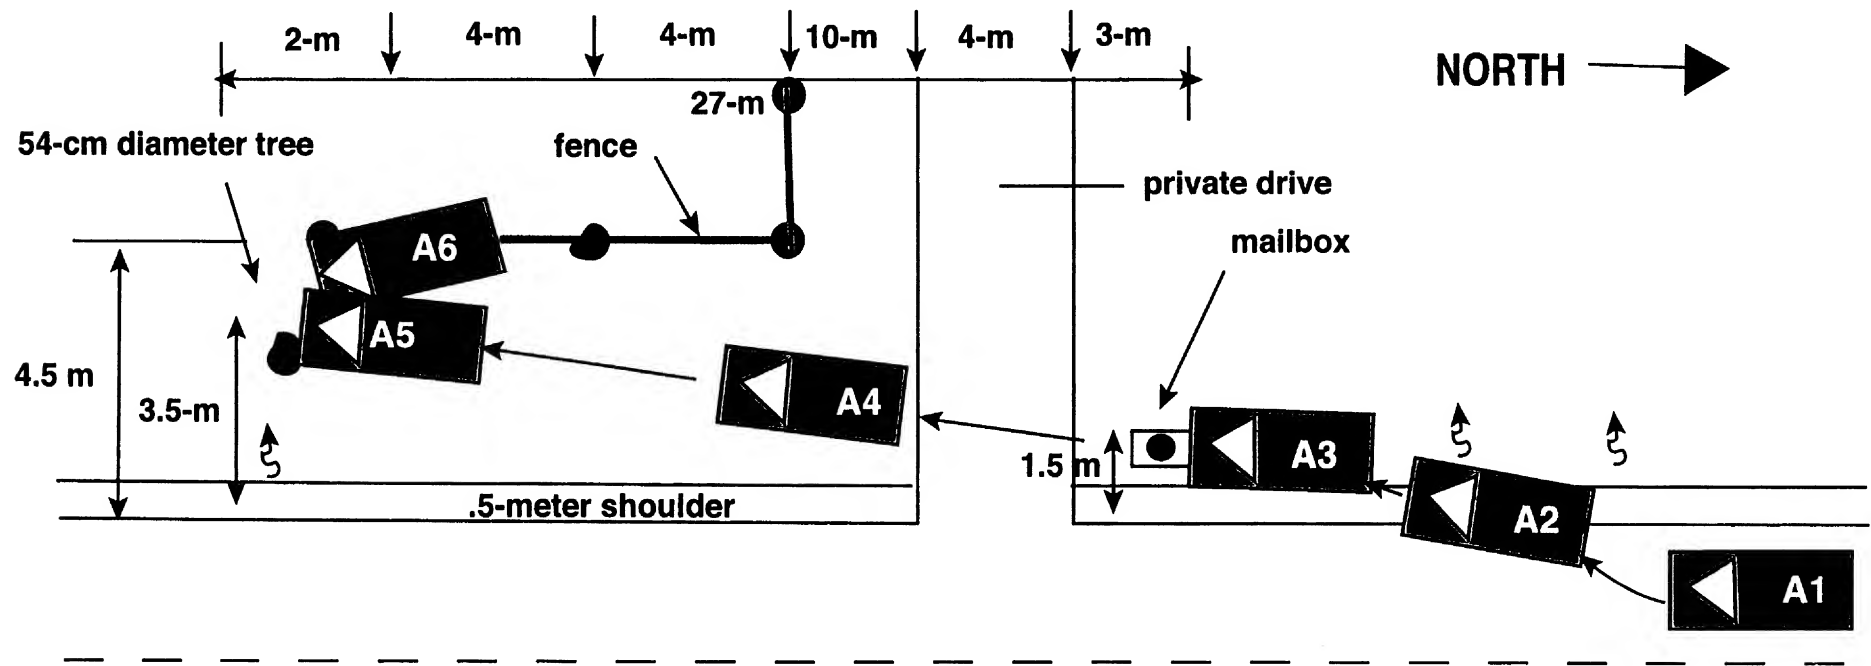
ACCIDENT SCHEMATIC

ACCIDENT DESCRIPTION: CASE VEHICLE (A) WAS SOUTHBOUND
WHEN THE VEHICLE LEFT THE WEST EDGE OF
THE ROAD. IT TRAVELED IN A SMALL DITCH AND
STRUCK A MAILBOX WITH ITS FRONT. IT CONTINUED SOUTHBOUND, CROSSED A
PRIVATE DRIVE AND STRUCK A 54-CM TREE WITH ITS LEFT-FRONT CORNER.
AFTER THE IMPACT WITH THE TREE, THE VEHICLE ROTATED COUNTERCLOCKWISE
AND STRUCK A FENCE POST WITH ITS RIGHT FENDER.

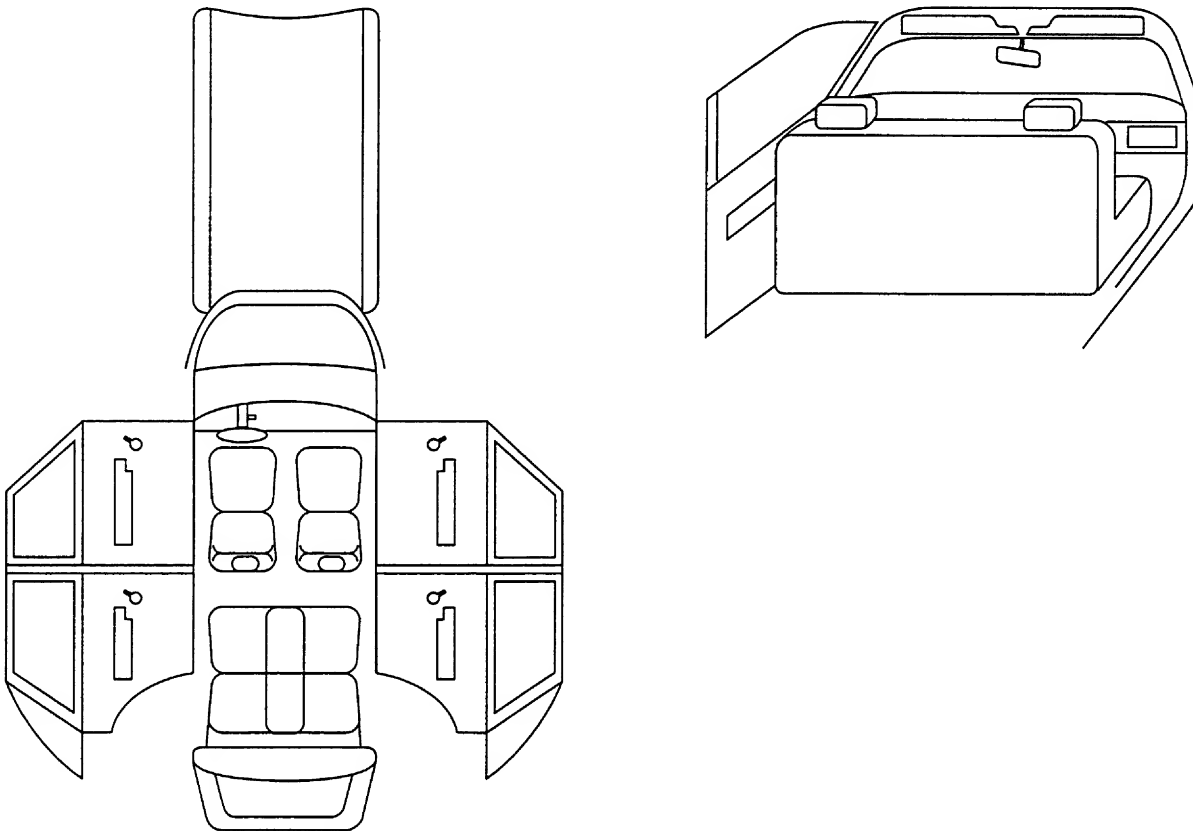
VEHICLE OCCUPANT CONTACT DIAGRAM

A = interior door panel at the window
frame junction (hair, blood, skin)

E = upper IP (scuff mark) C = steering wheel (bent)

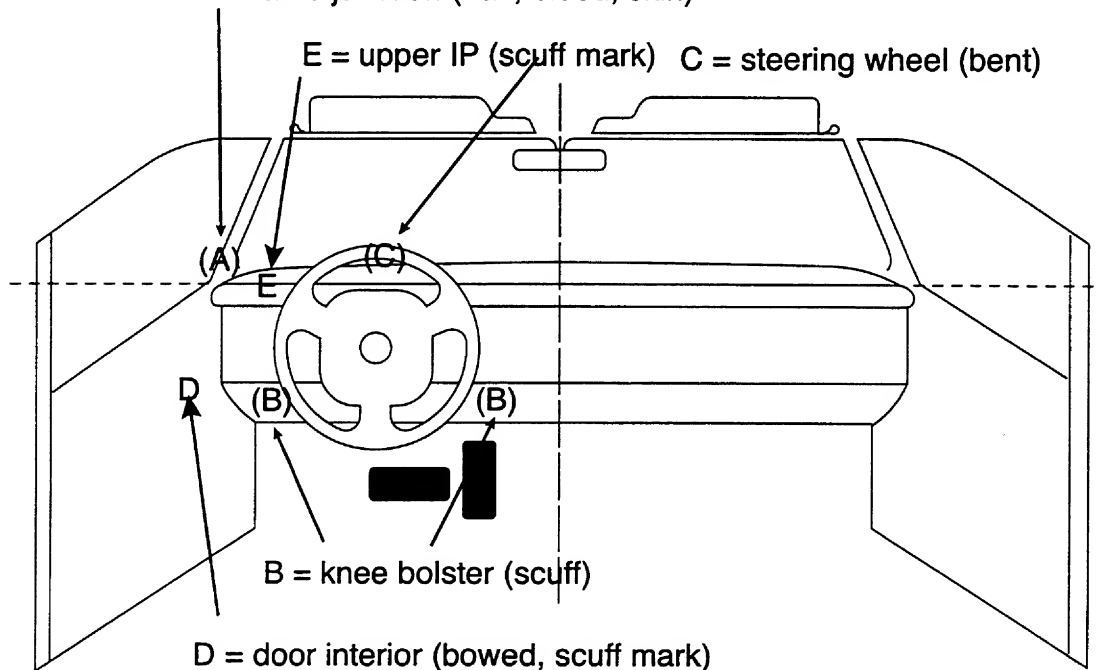
B = knee bolster (scuff)

D = door interior (bowed, scuff mark)

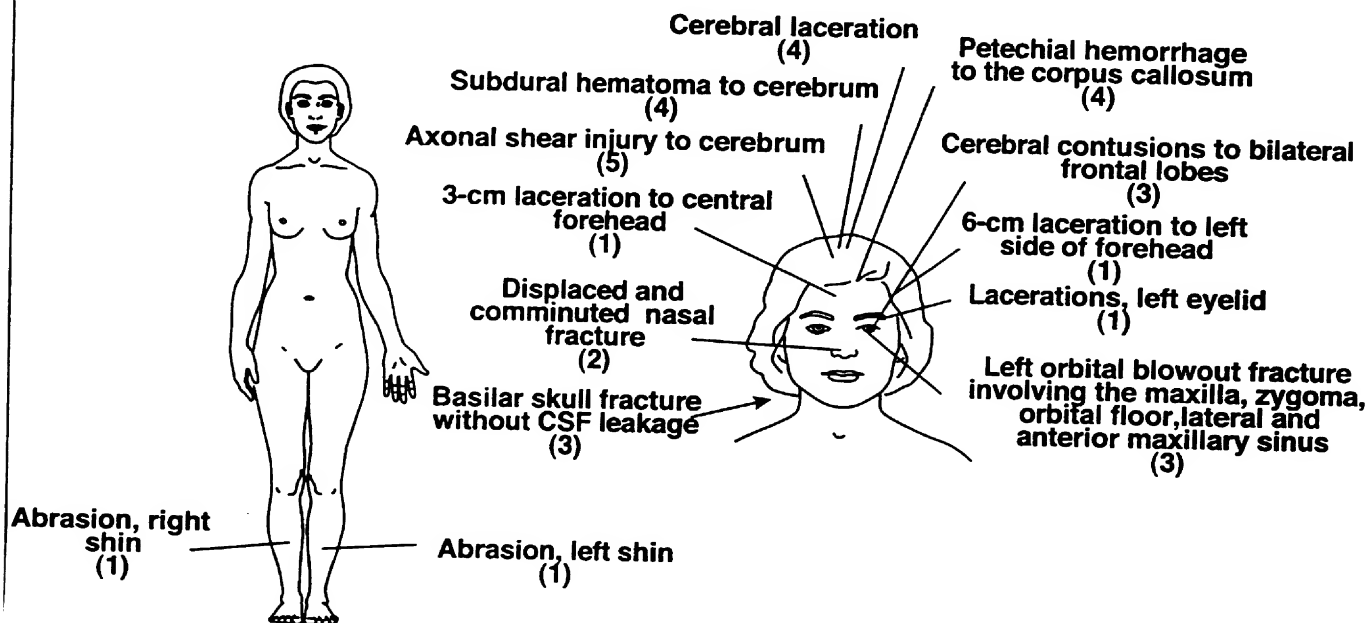
INDICATE LOCATION OF INJURIES.

The following table and attached drawing (slide 79) summarize the injuries for the unbelted driver.

etoh = .18 percent blood + for opiates
